**Coal Combustion Waste Impoundment
Round 5 - Dam Assessment Report**

Winyah Generating Station (Site #004)

**Santee Cooper
Georgetown, South Carolina**

Under Contract Number: EP-09W001727
January 2011

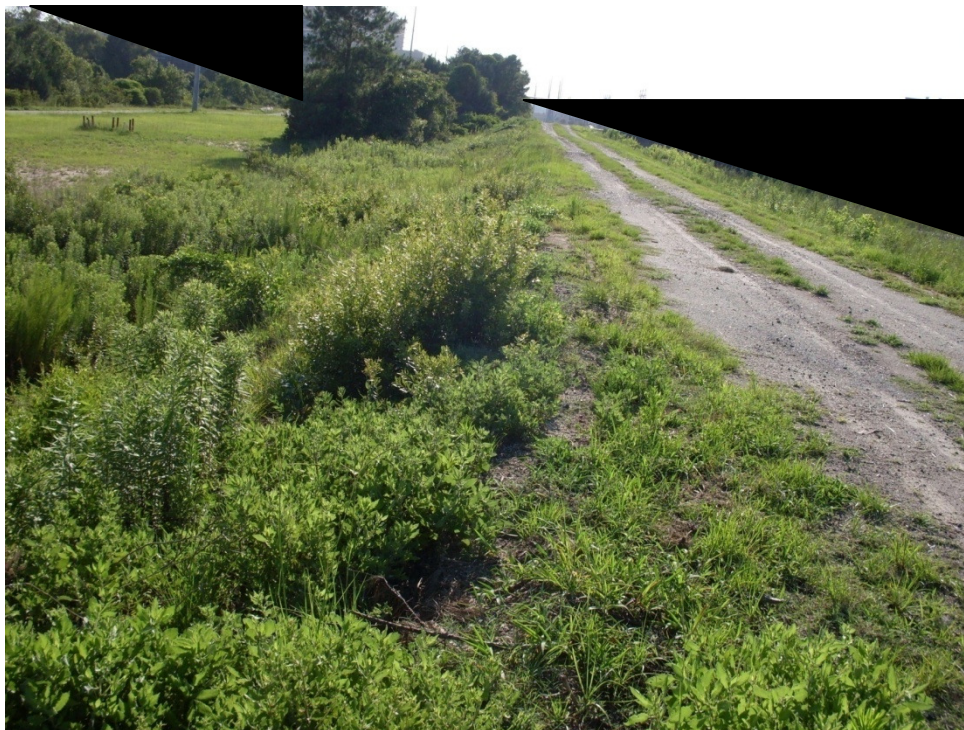
Photo B2-13: Outside Crest and Slope of Perimeter Dike South Side of Unit 2 Slurry Pond West of Cross

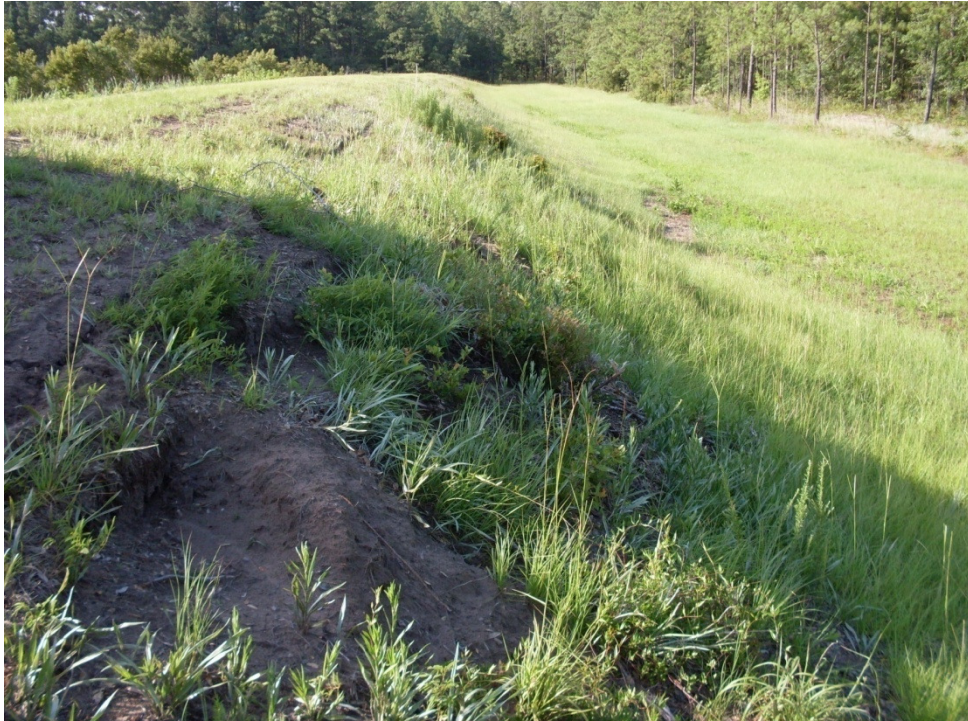
Photo B2-14: Outside Slope of Perimeter Dike East Side of Unit 2 Slurry Pond
– Viewed South

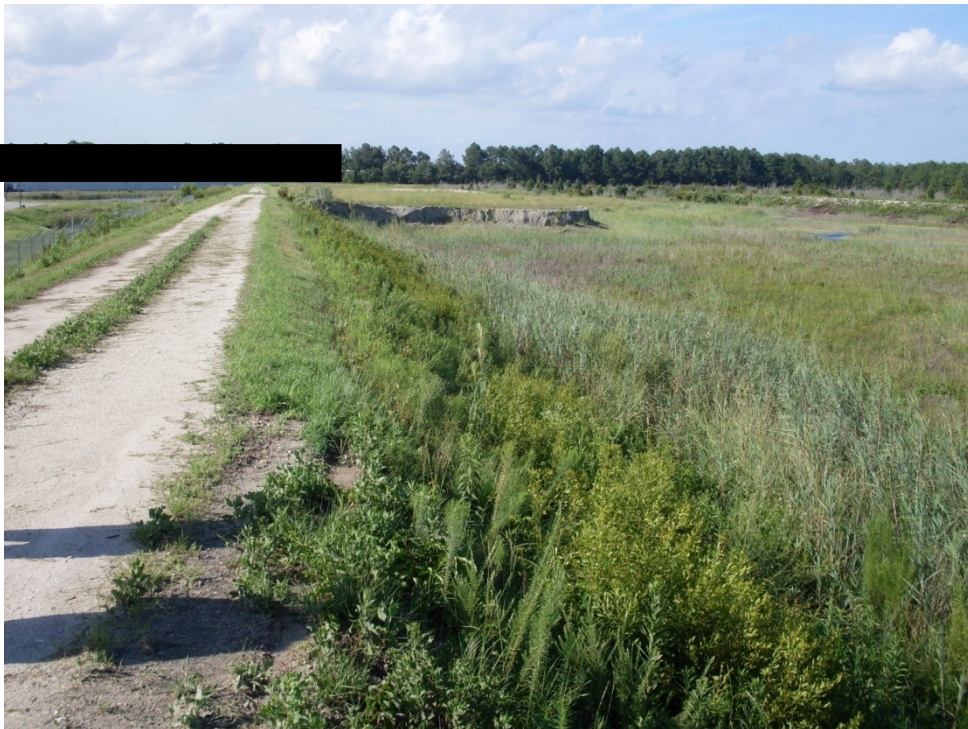
Photo B2-15: Inside Slope of Perimeter Dike West Side of Unit 2 Slurry Pond–
Viewed North.

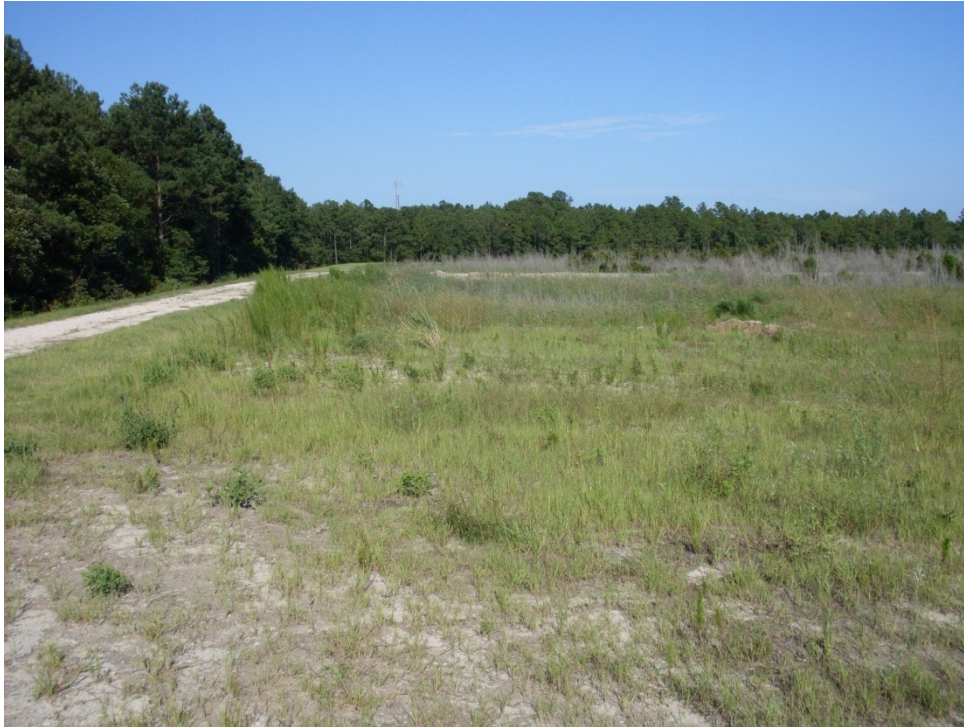
Photo B2-16: Inside Slope of Perimeter Dike North Side of Unit 2 Slurry Pond
West of Cross Dike – Viewed East.

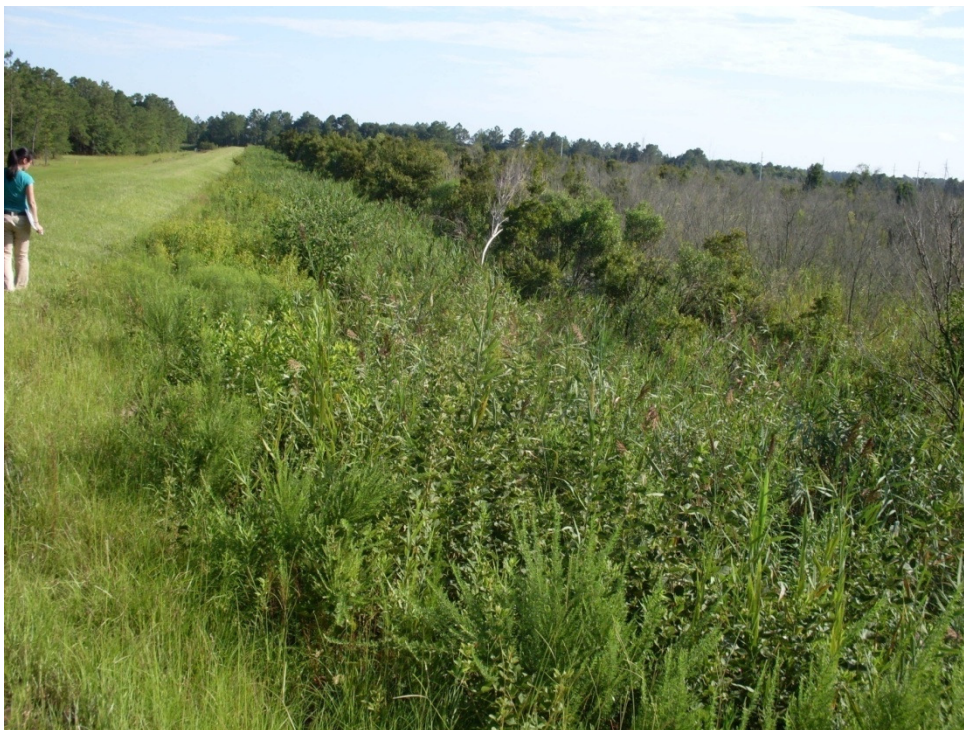
Photo B2-17: Inside Slope of Perimeter Dike East Side of Unit 2 Slurry
Pond– Viewed South.

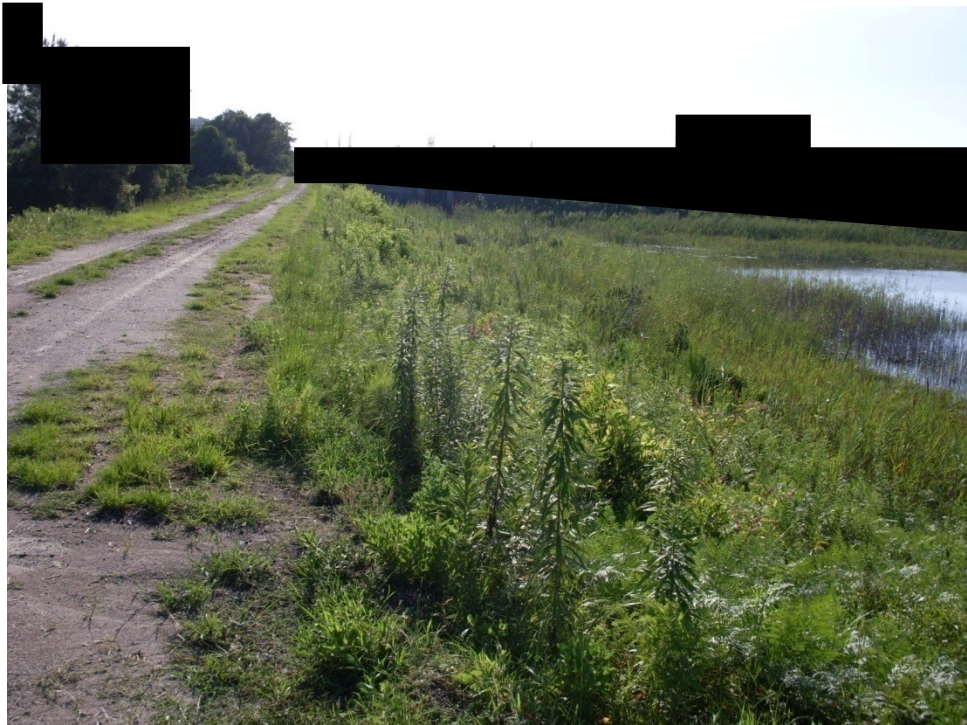
Photo B2-18: Inside Slope and Crest of Perimeter Dike South Side of Unit 2
Slurry Pond West of Cross Dike – Viewed West.

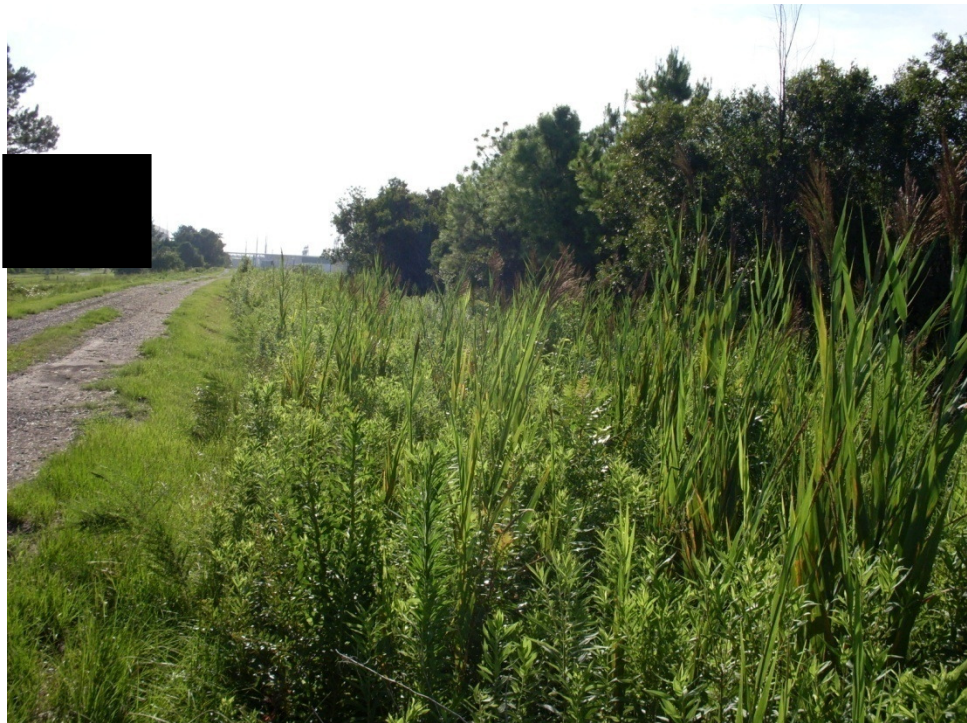
Photo B2-19: Inside Slope and Crest of Perimeter Dike South Side of Unit 2
Slurry Pond East of Cross Dike– Viewed West.

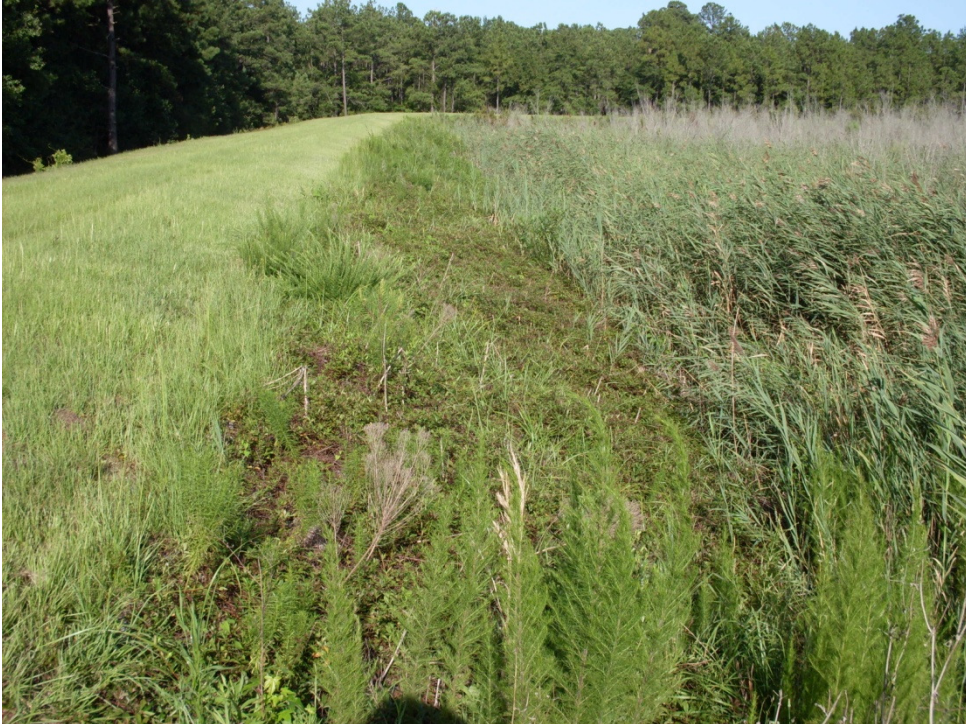
Photo B2-20: Inside Slope of Perimeter Dike North Side of Unit 2 Slurry Pond
East of Cross Dike – Viewed East.

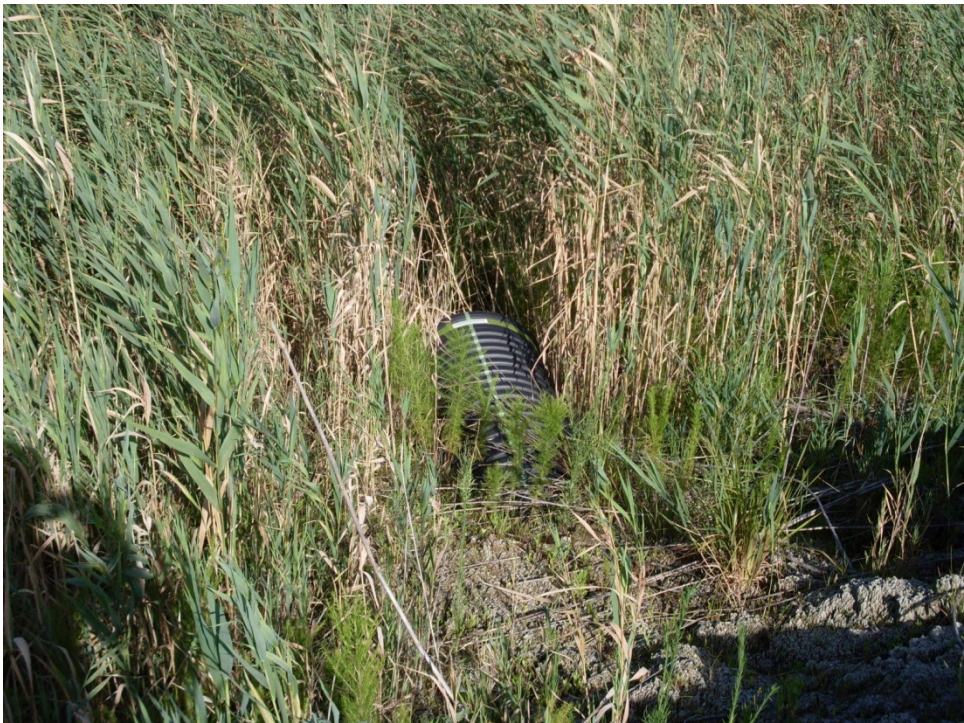
Photo B2-23: Inlet of Corrugated HDPE Pipe Under the North (Extended) Portion of the Cross Dike in Unit

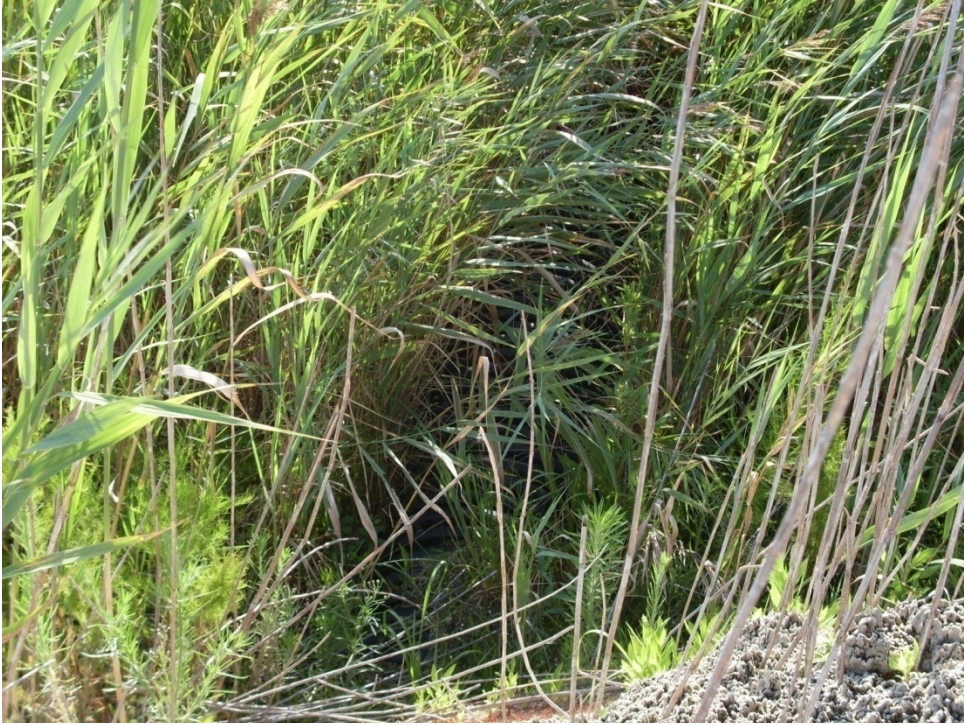
Photo B2-24: Outlet of Corrugated HDPE Pipe Under the North (Extended) Portion of the Cross Dike in Unit 2 Slurry Pond.

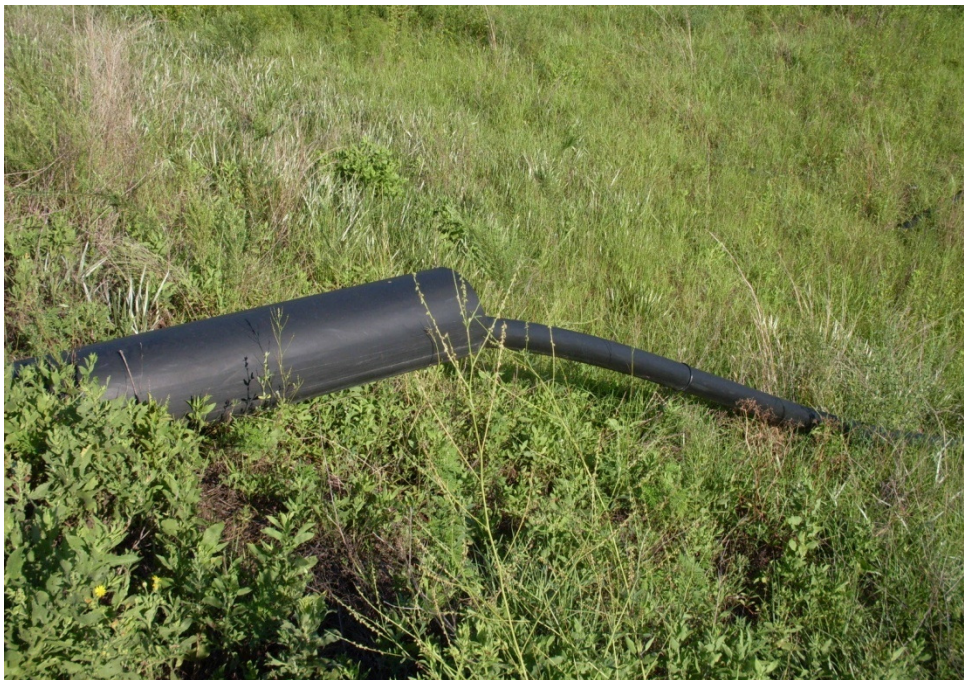
Photo B2-25: Plastic Pipe Conveying Stormwater Pumped Unit 2 Slurry Pond to Intake Channel Located at Outside Slope of South Perimeter Dike at Southwest Corner. (Note Large Diameter Casing Pipe within which Discharge Line – Smaller Pipe – Passes under Crest of Dike.)
